FIC-LIC summary results

E. Nebot, B. Dehning, E. Effinger, V. Grishin.

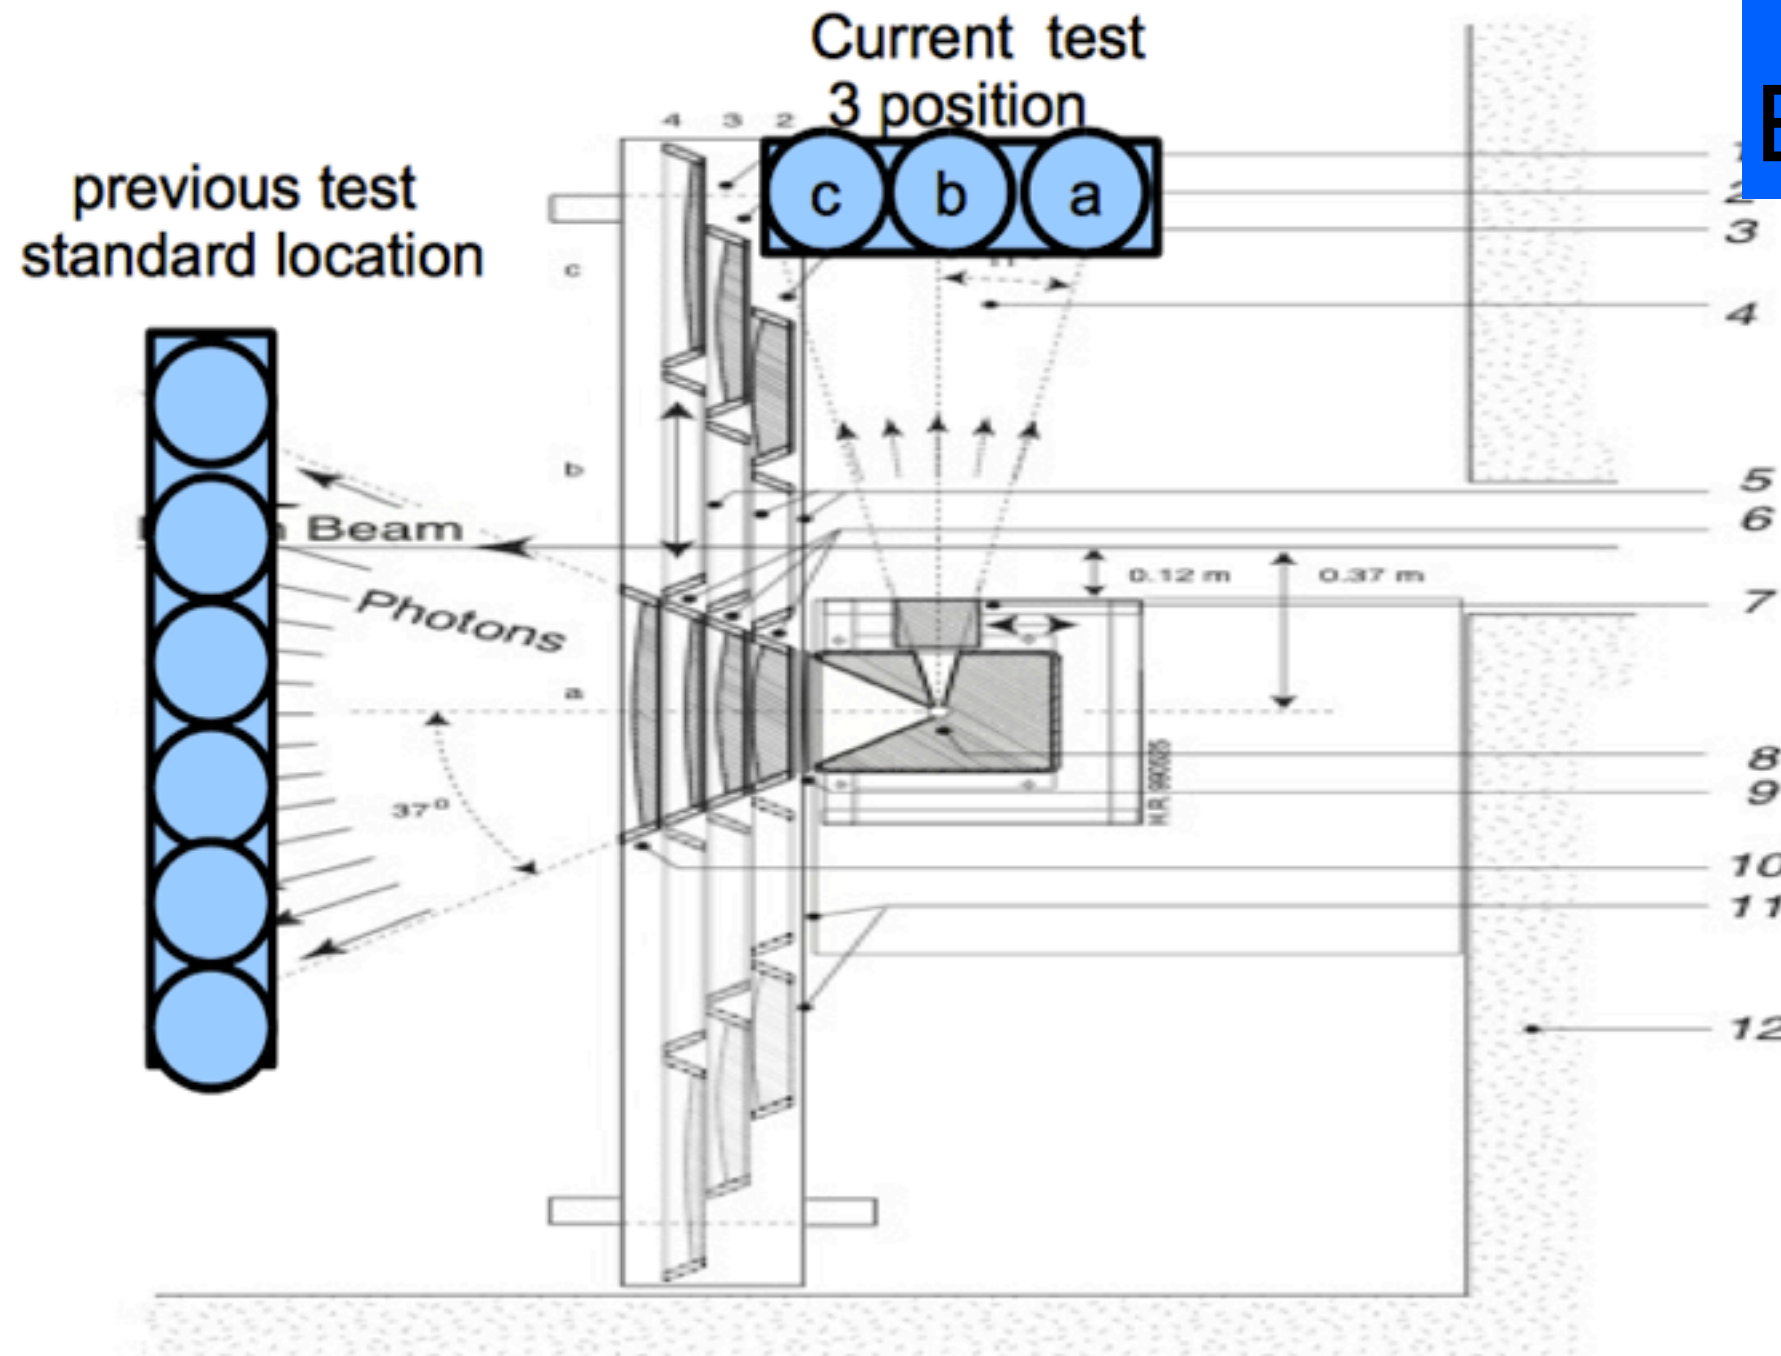
- Measurements performed in lateral collimator
- Not standard place for previous calibrations

Source
Cs137
 $E_{\gamma}=662\text{KeV}$

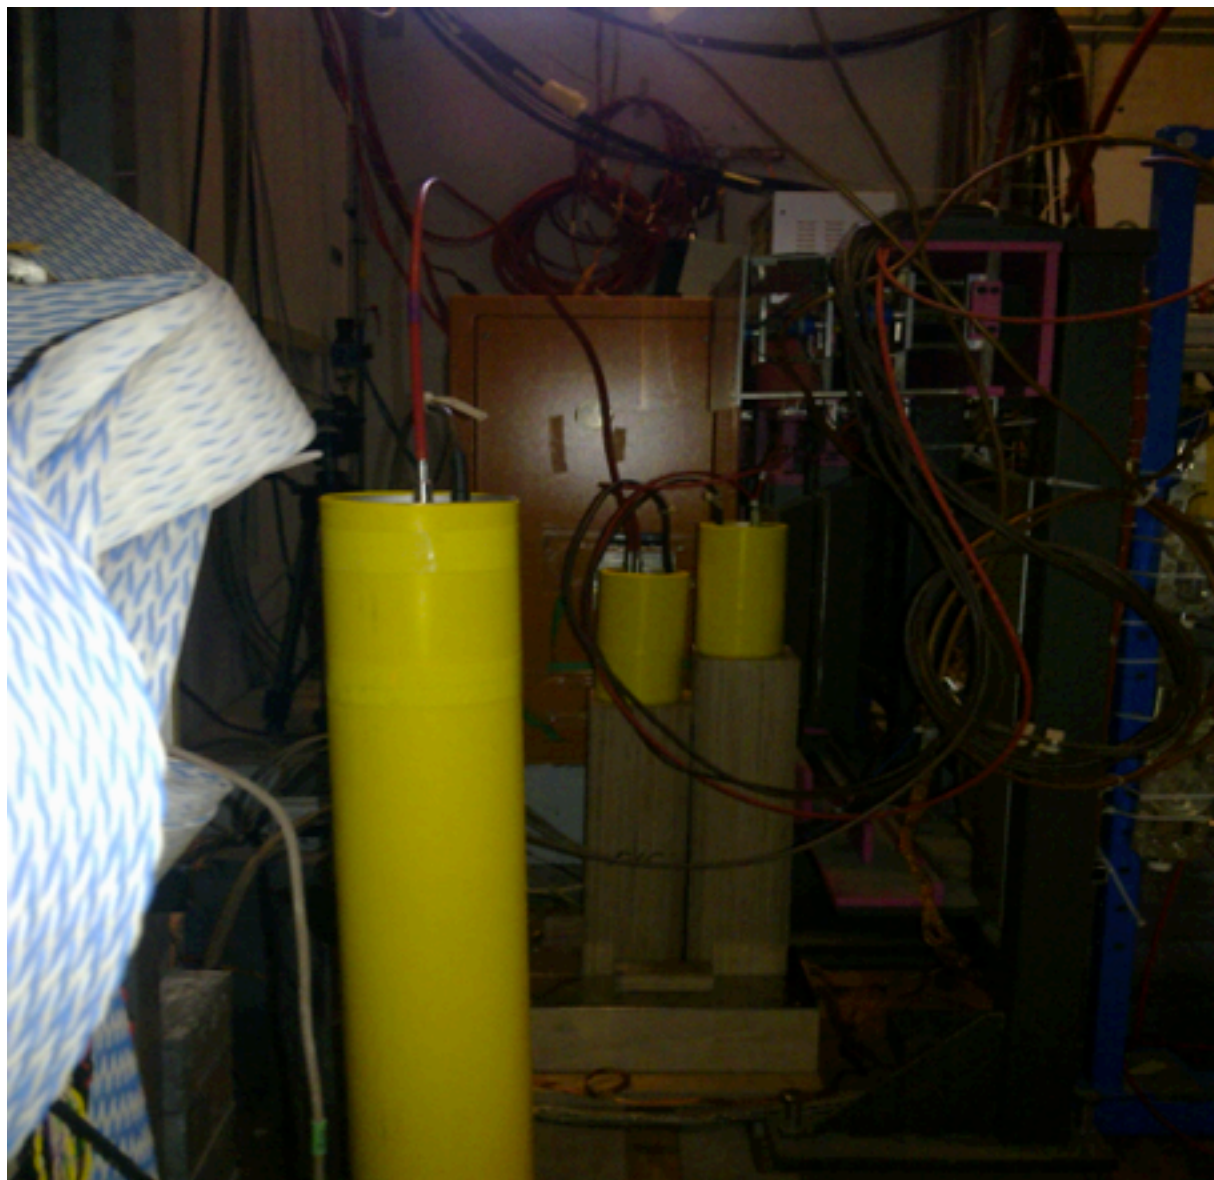
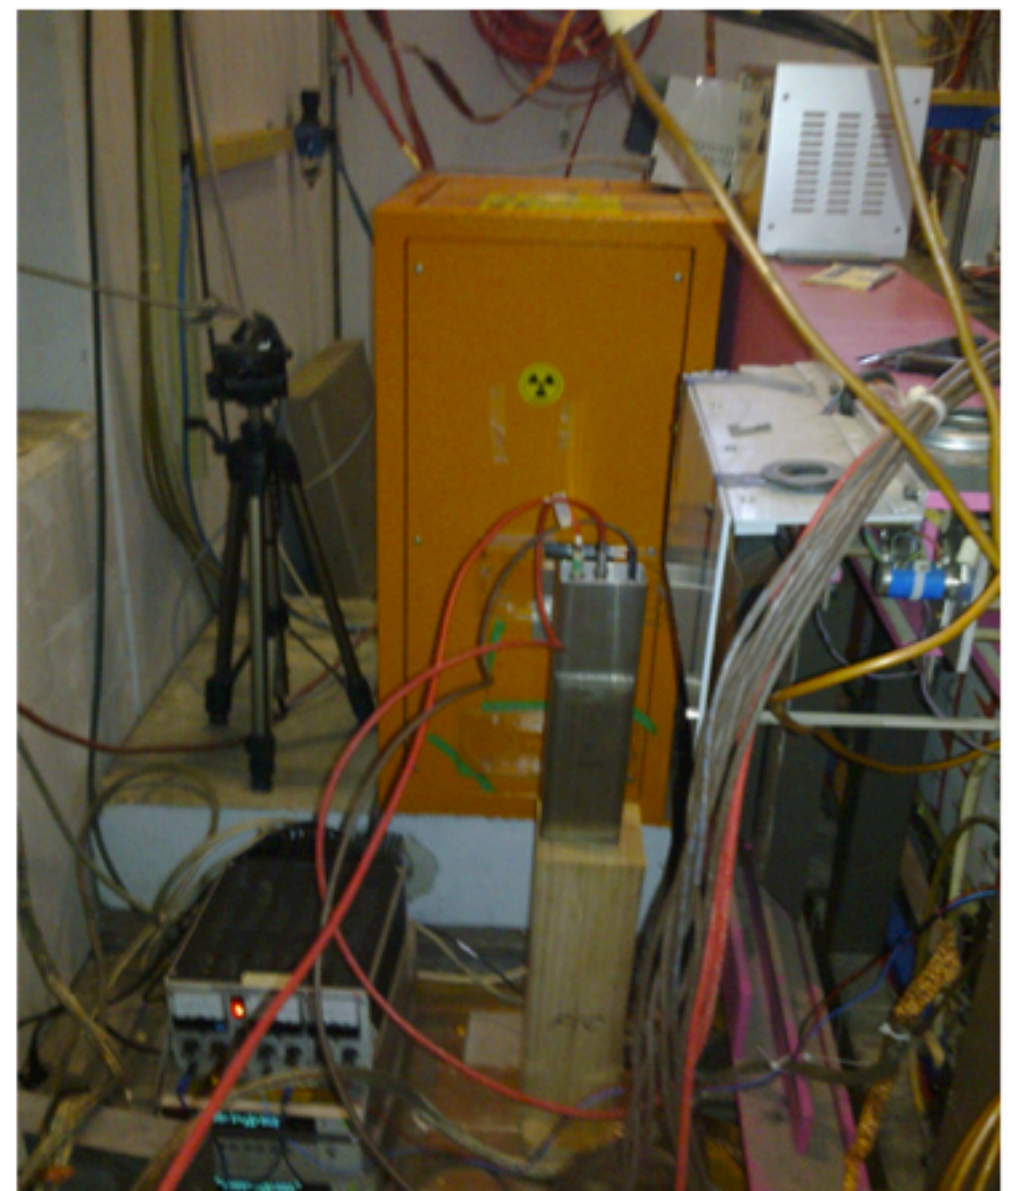
- View of detector location in lateral collimator.
- Signals integrated over 1 s (50 seconds/measurement)

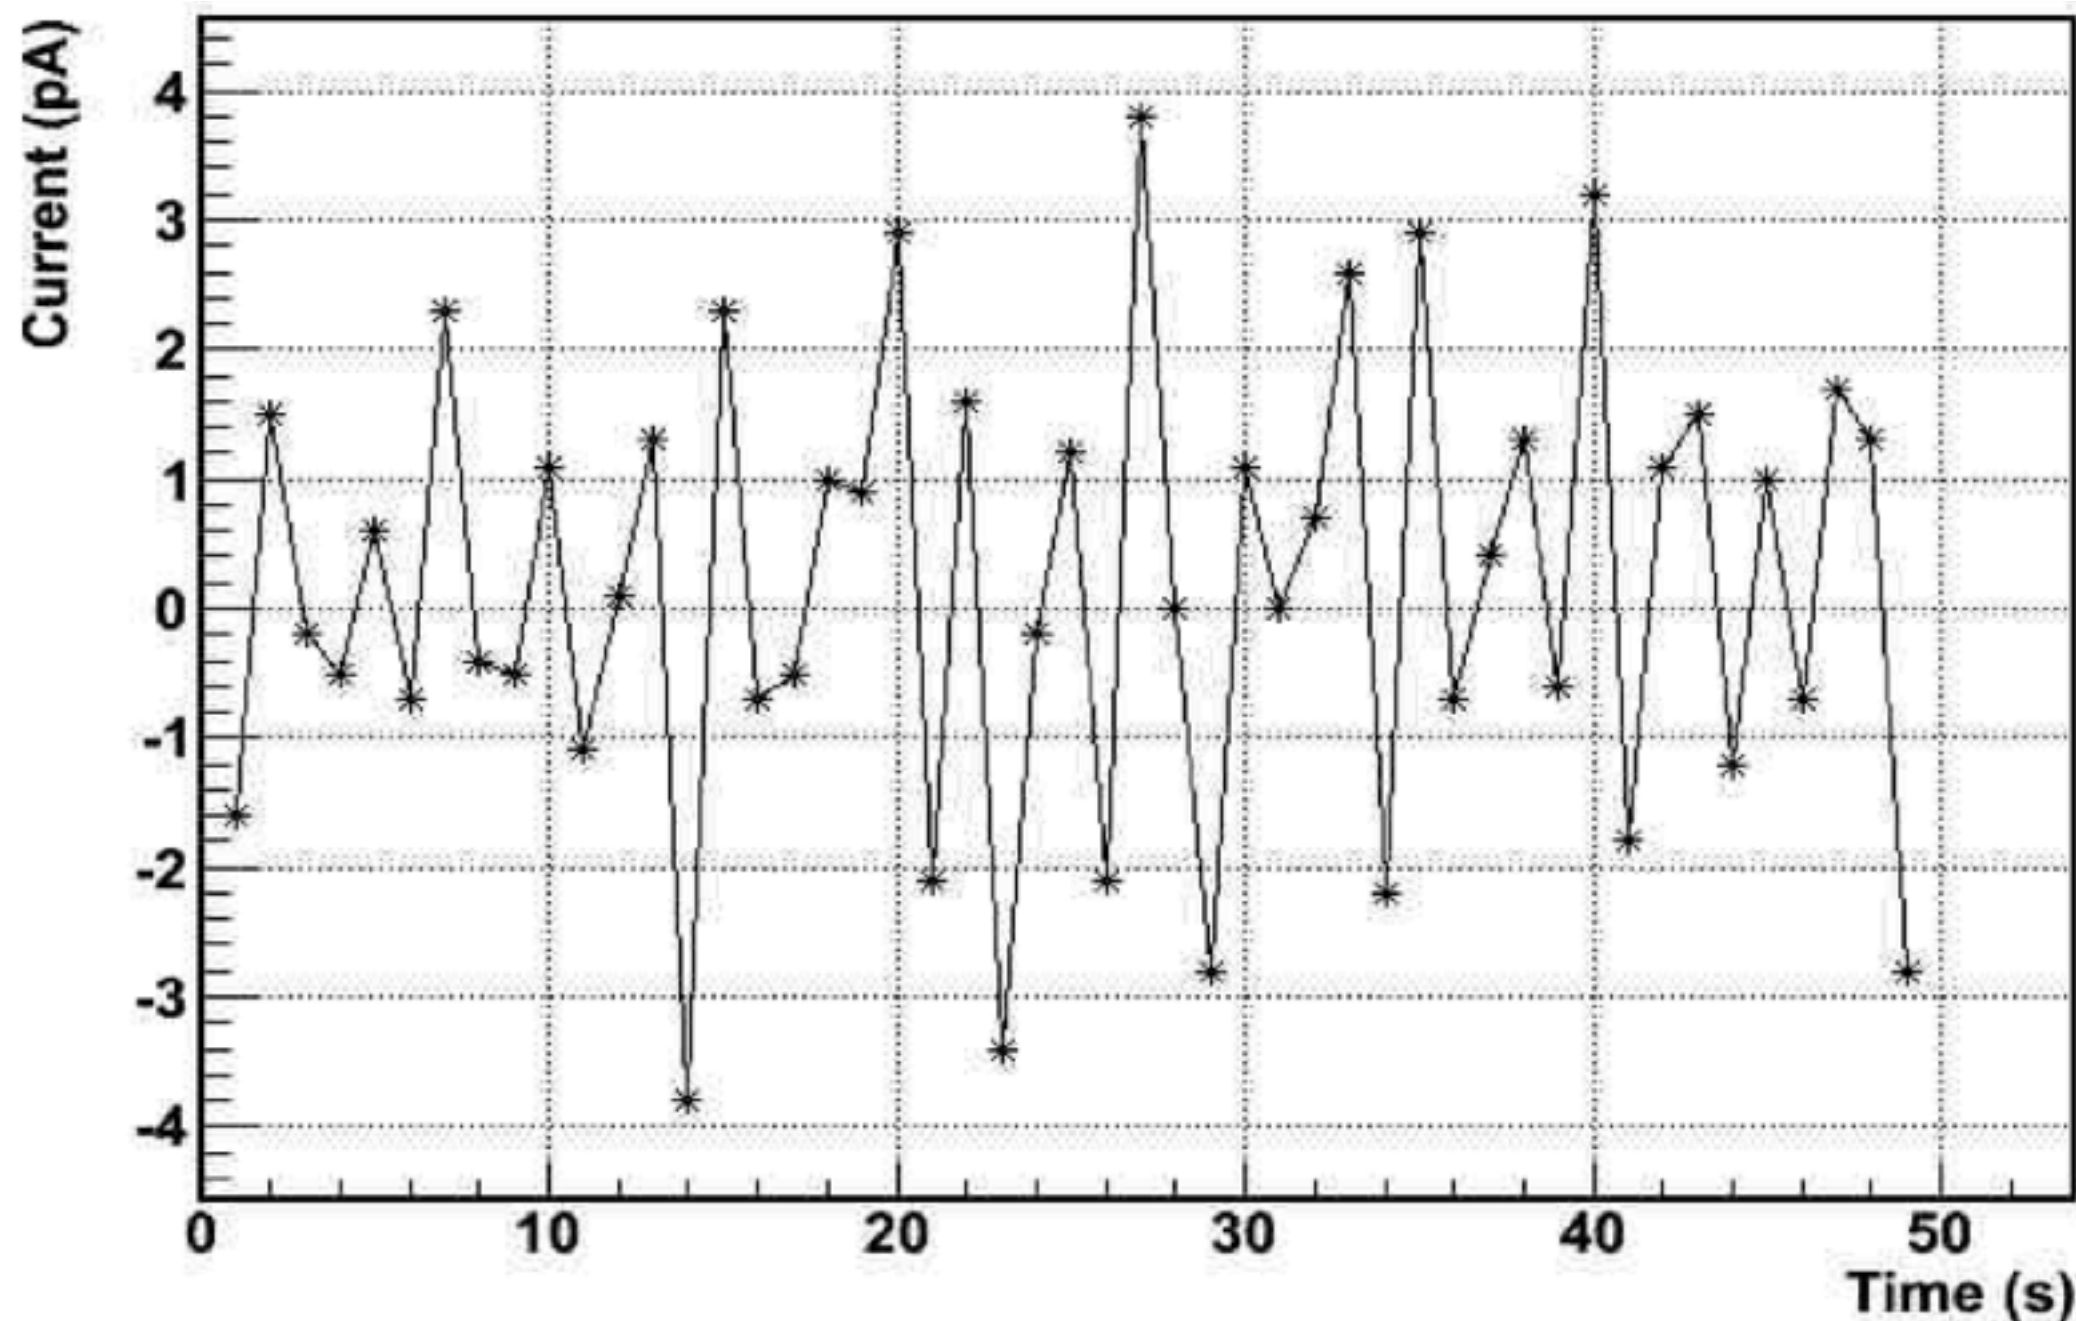
- Several measurements without radiation source.
- High offset current ($-4 - 4$ pA) in FIC detectors

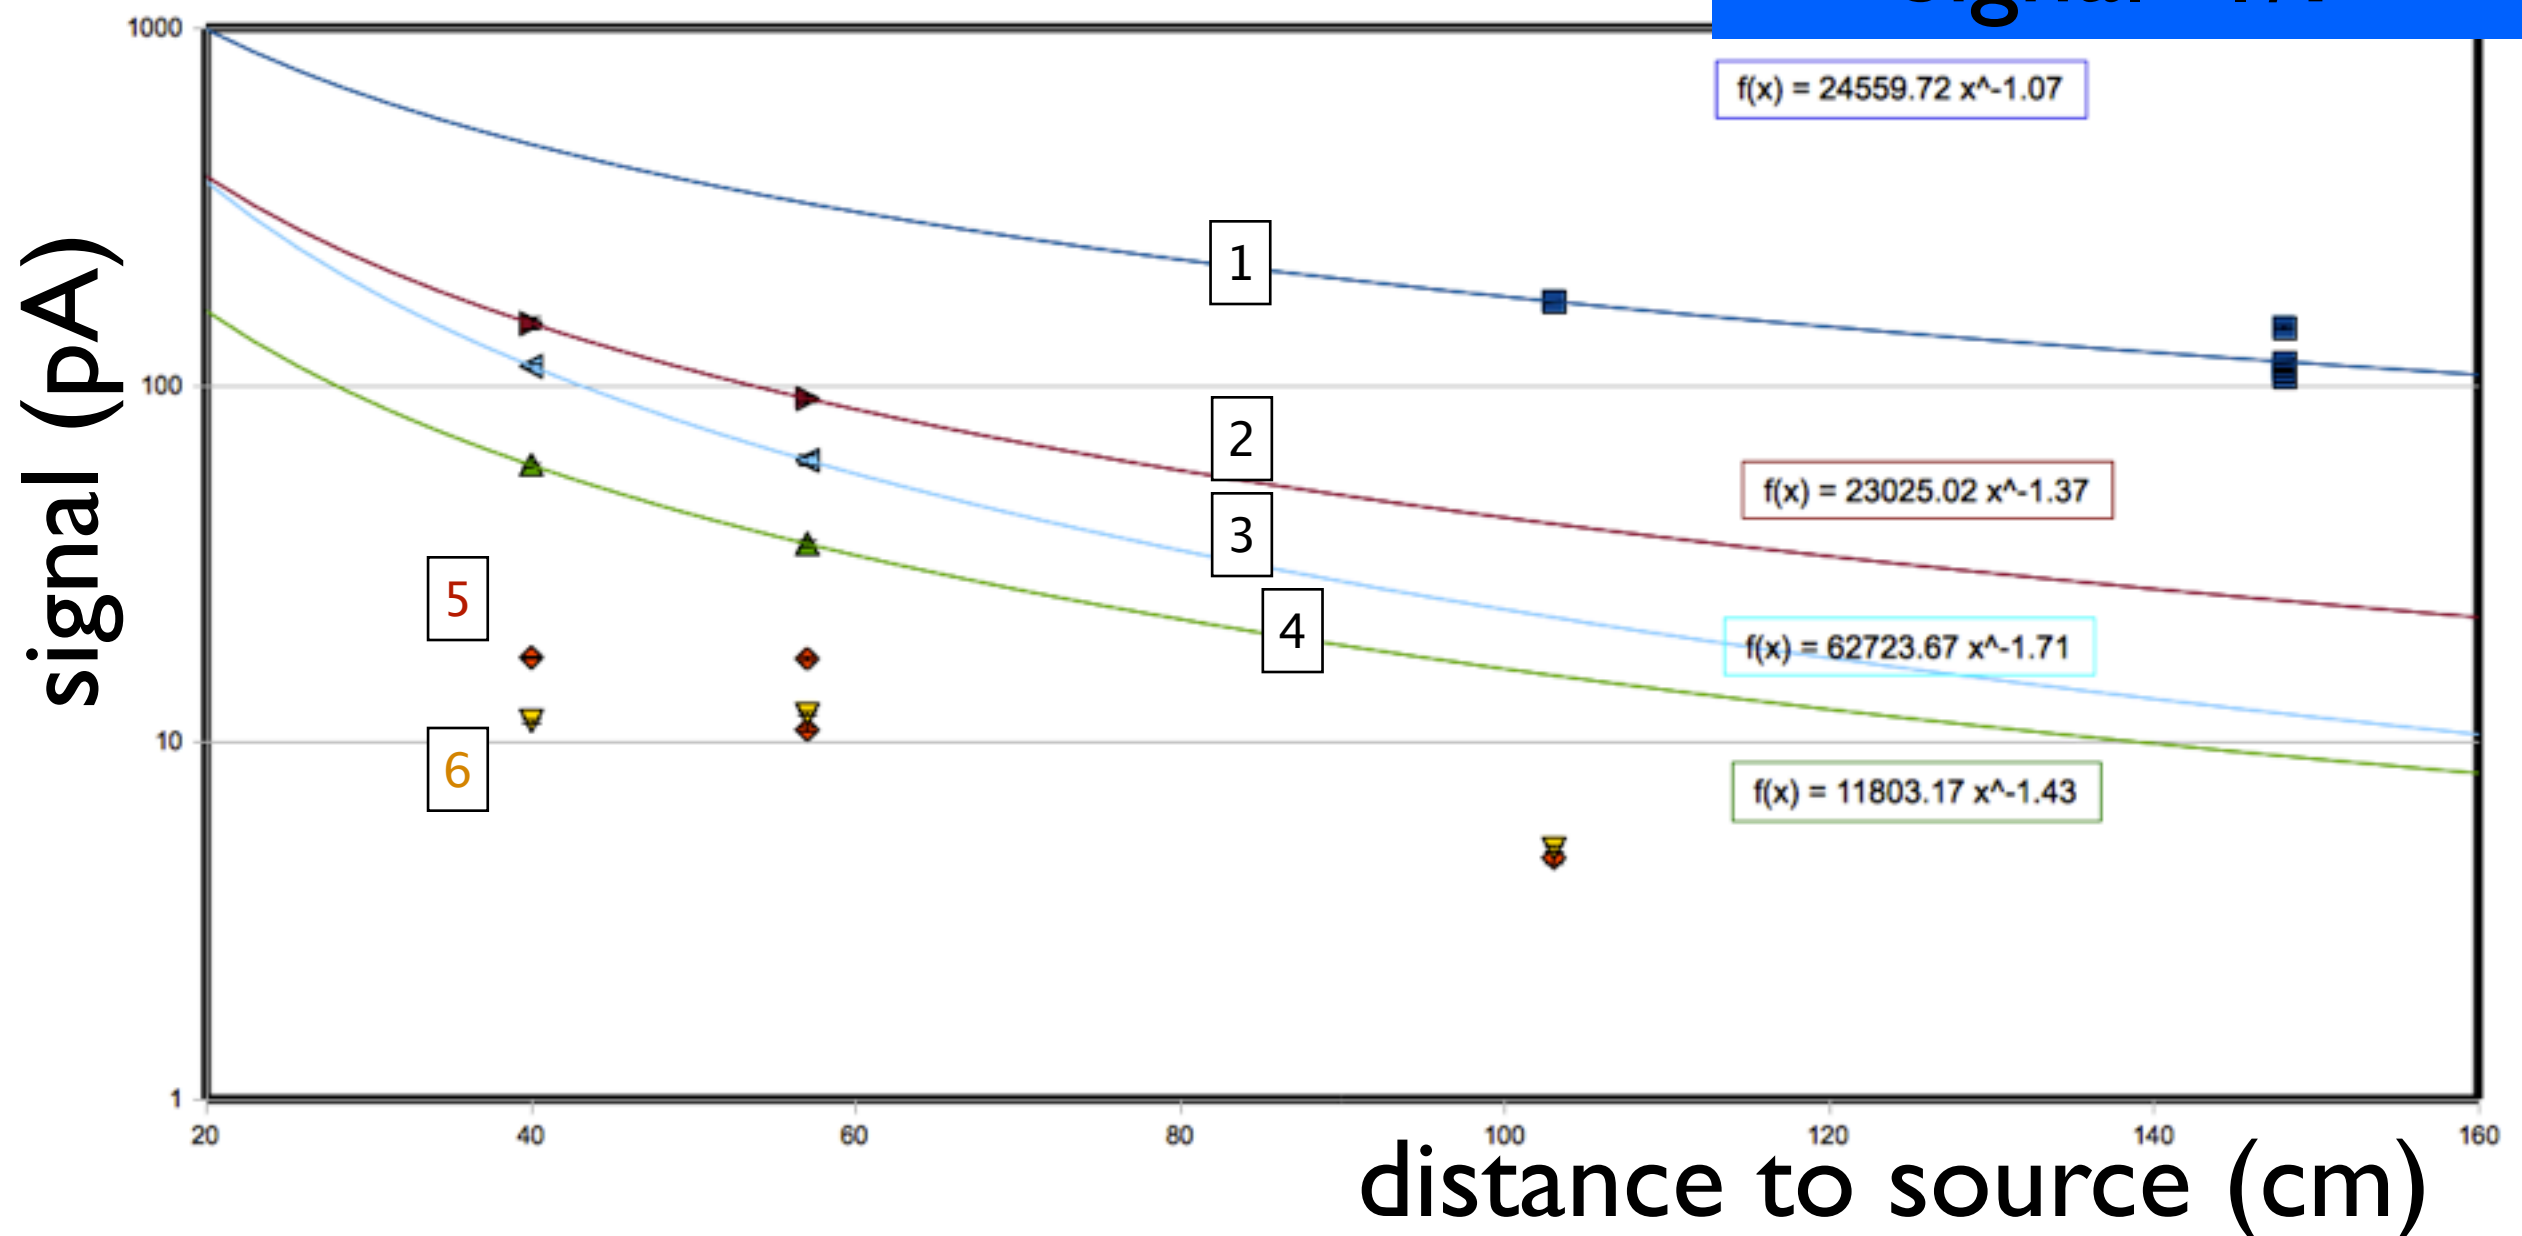
- 1) LHC-IC (position a)
- 2) FIC (position b) electrode perpendicular to source axis
- 3) FIC (position b) electrode parallel to source axis
- 4) refilled LIC (position b)
- 5) LIC 0.4 bar (position b)
- 6) LIC 0.4 bar (position c)

Expected
Signal $\sim 1/r^2$

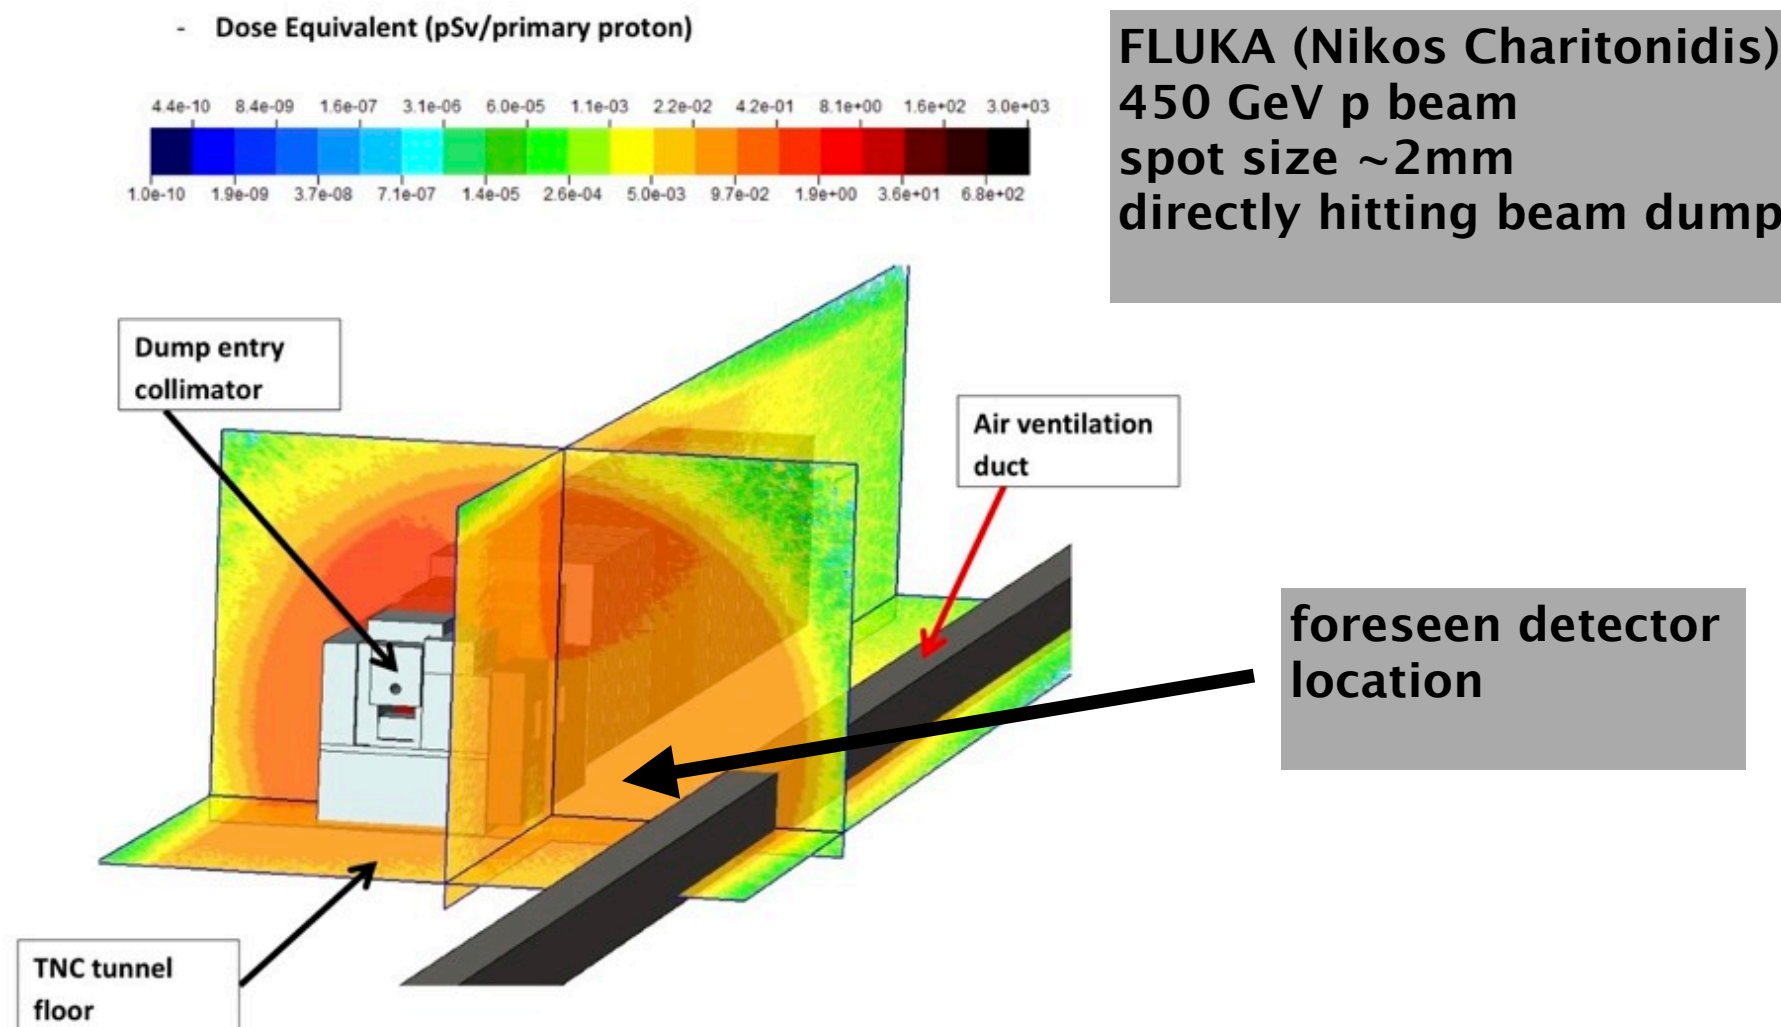
- High Radiation for Materials. SPS extraction line.
- Beam conditions: 450GeV, 1.5×10^{11} p/bunch. Up to 144 bunches with 50ns bunch spacing.
- Detectors located to see secondary showers. Full beam impacting on dump (iron block).

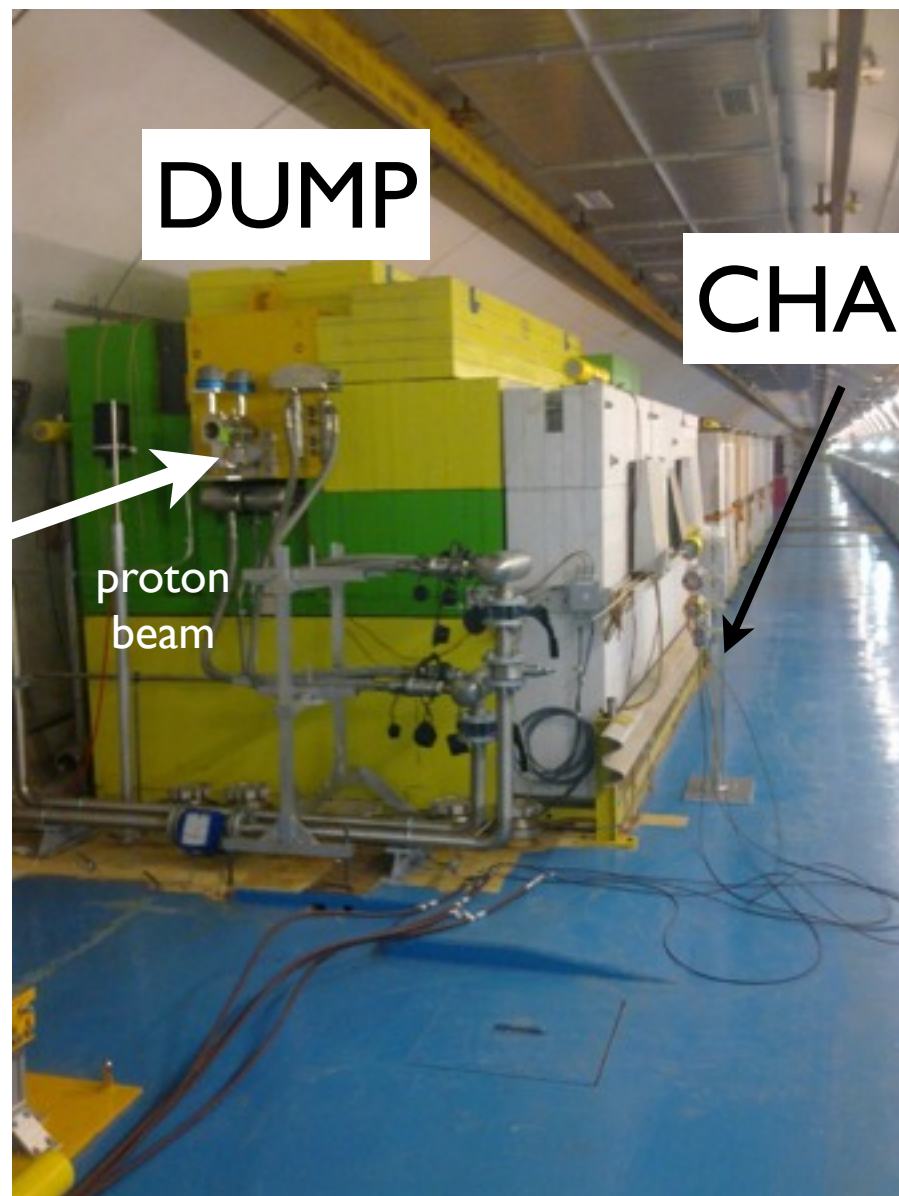
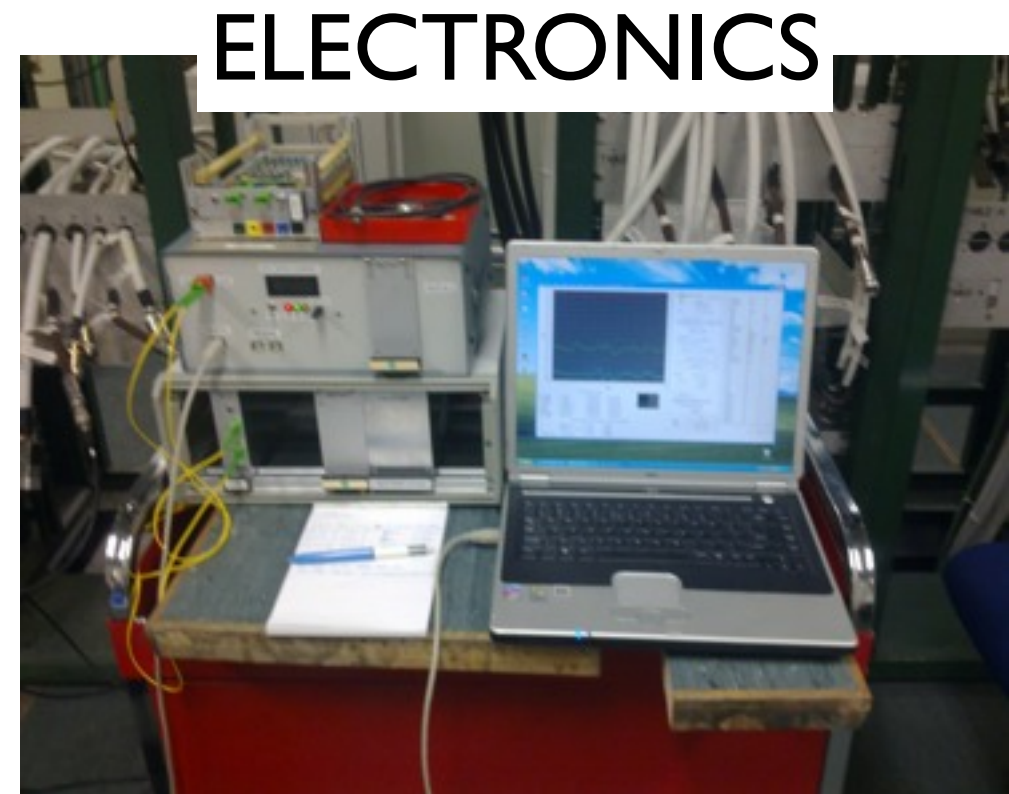
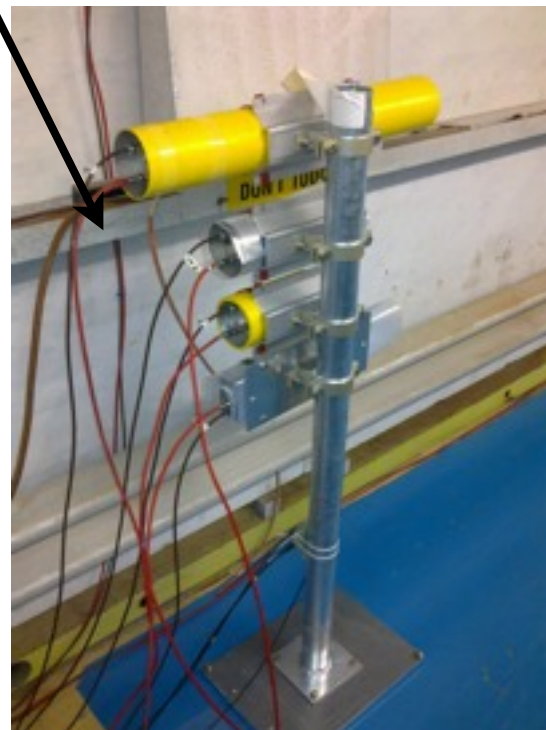
- Main parts of the experiment in photos

LHC-IC
LIC 1.1 bar
LIC 0.4 bar
FIC

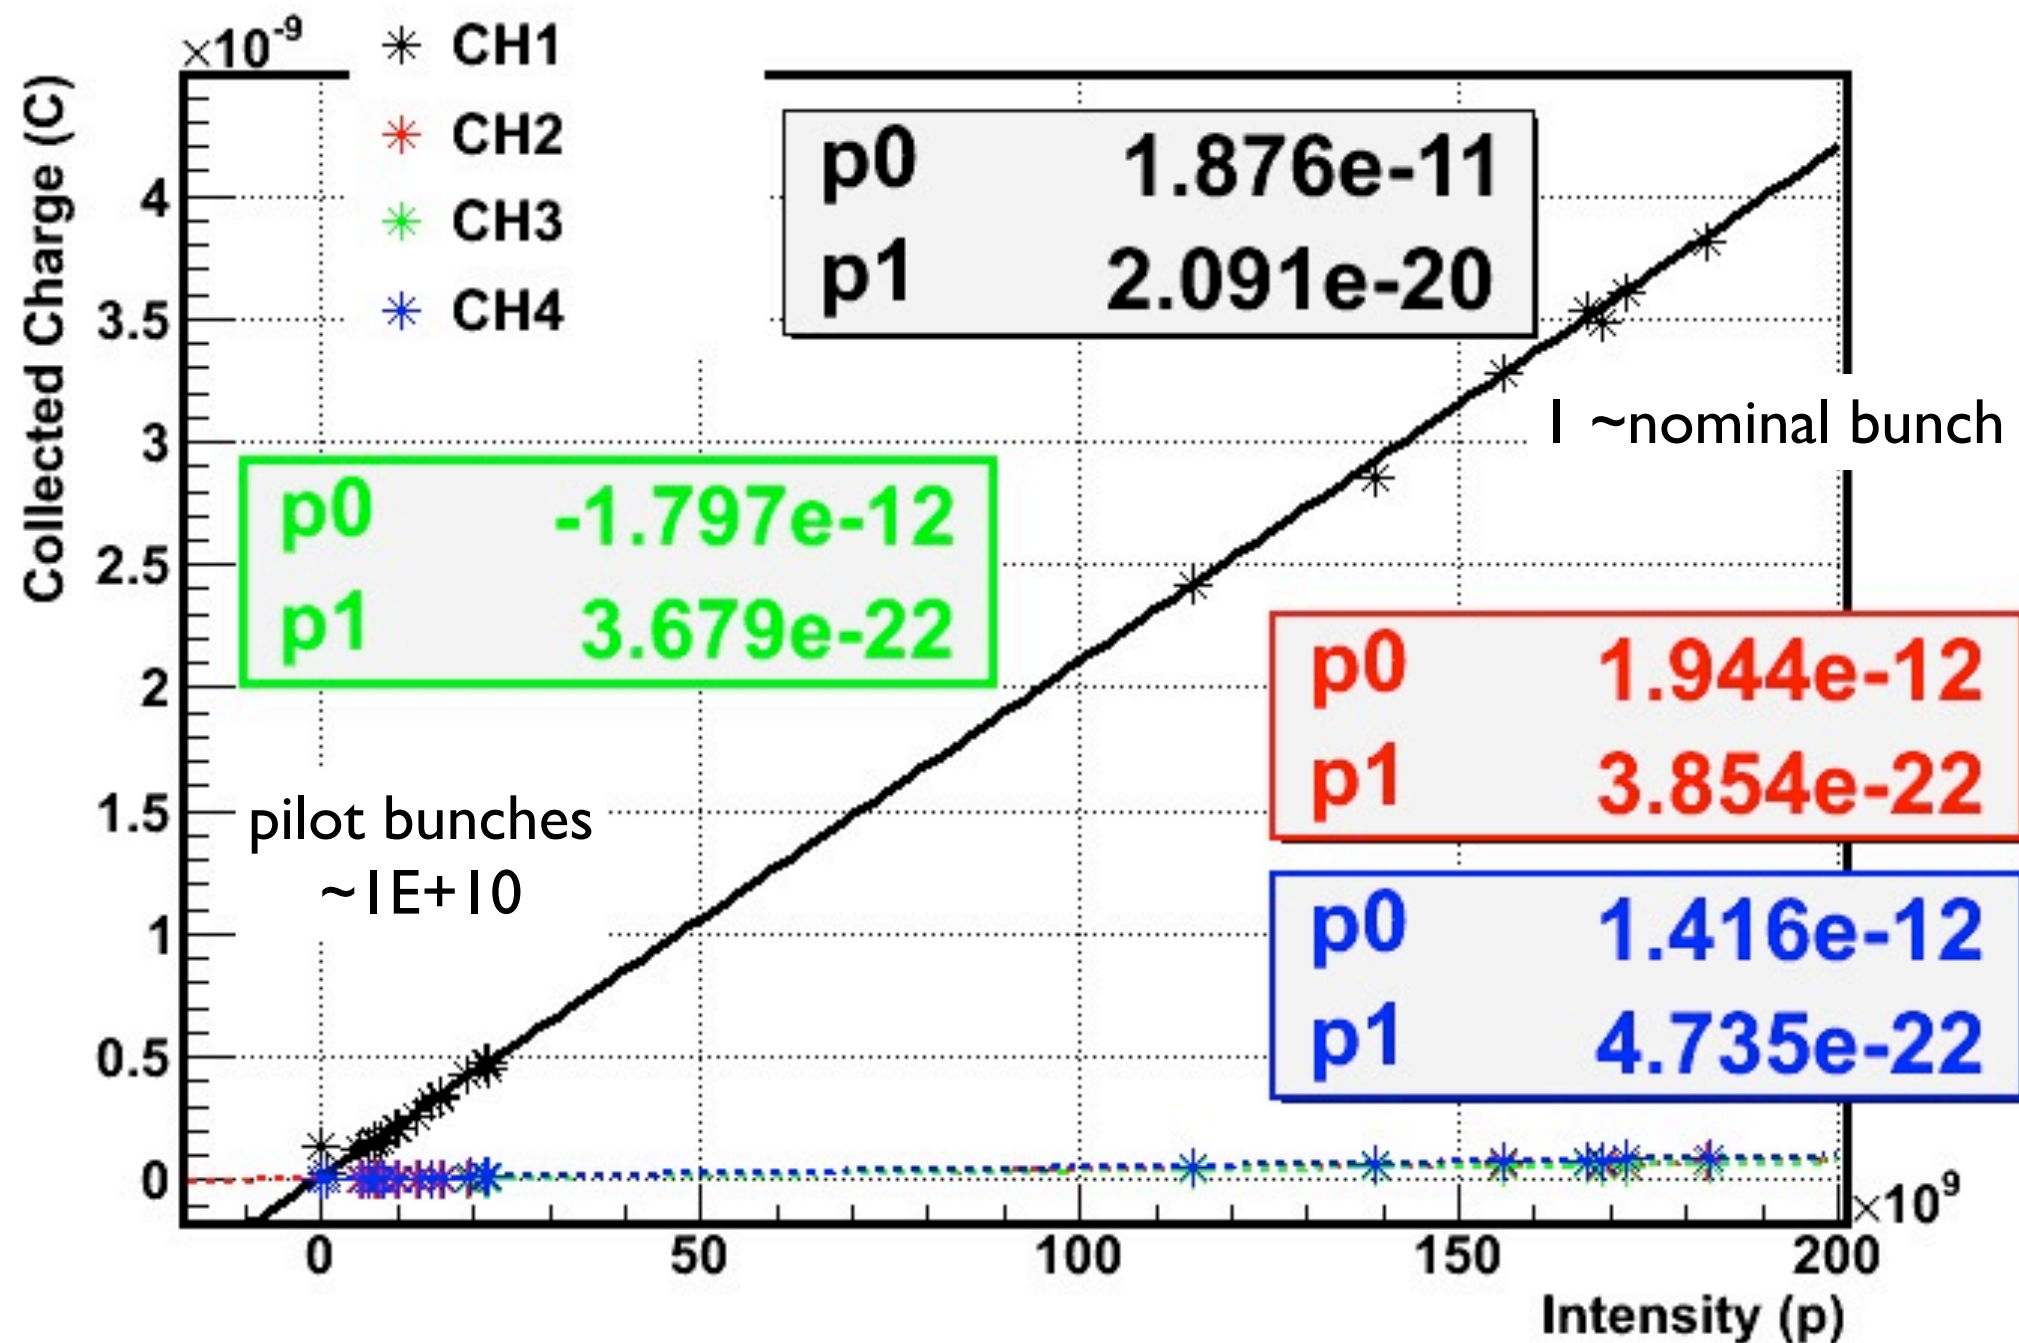
Signal (40us) vs Intensity

- Looks like a nice linear behaviour but.....

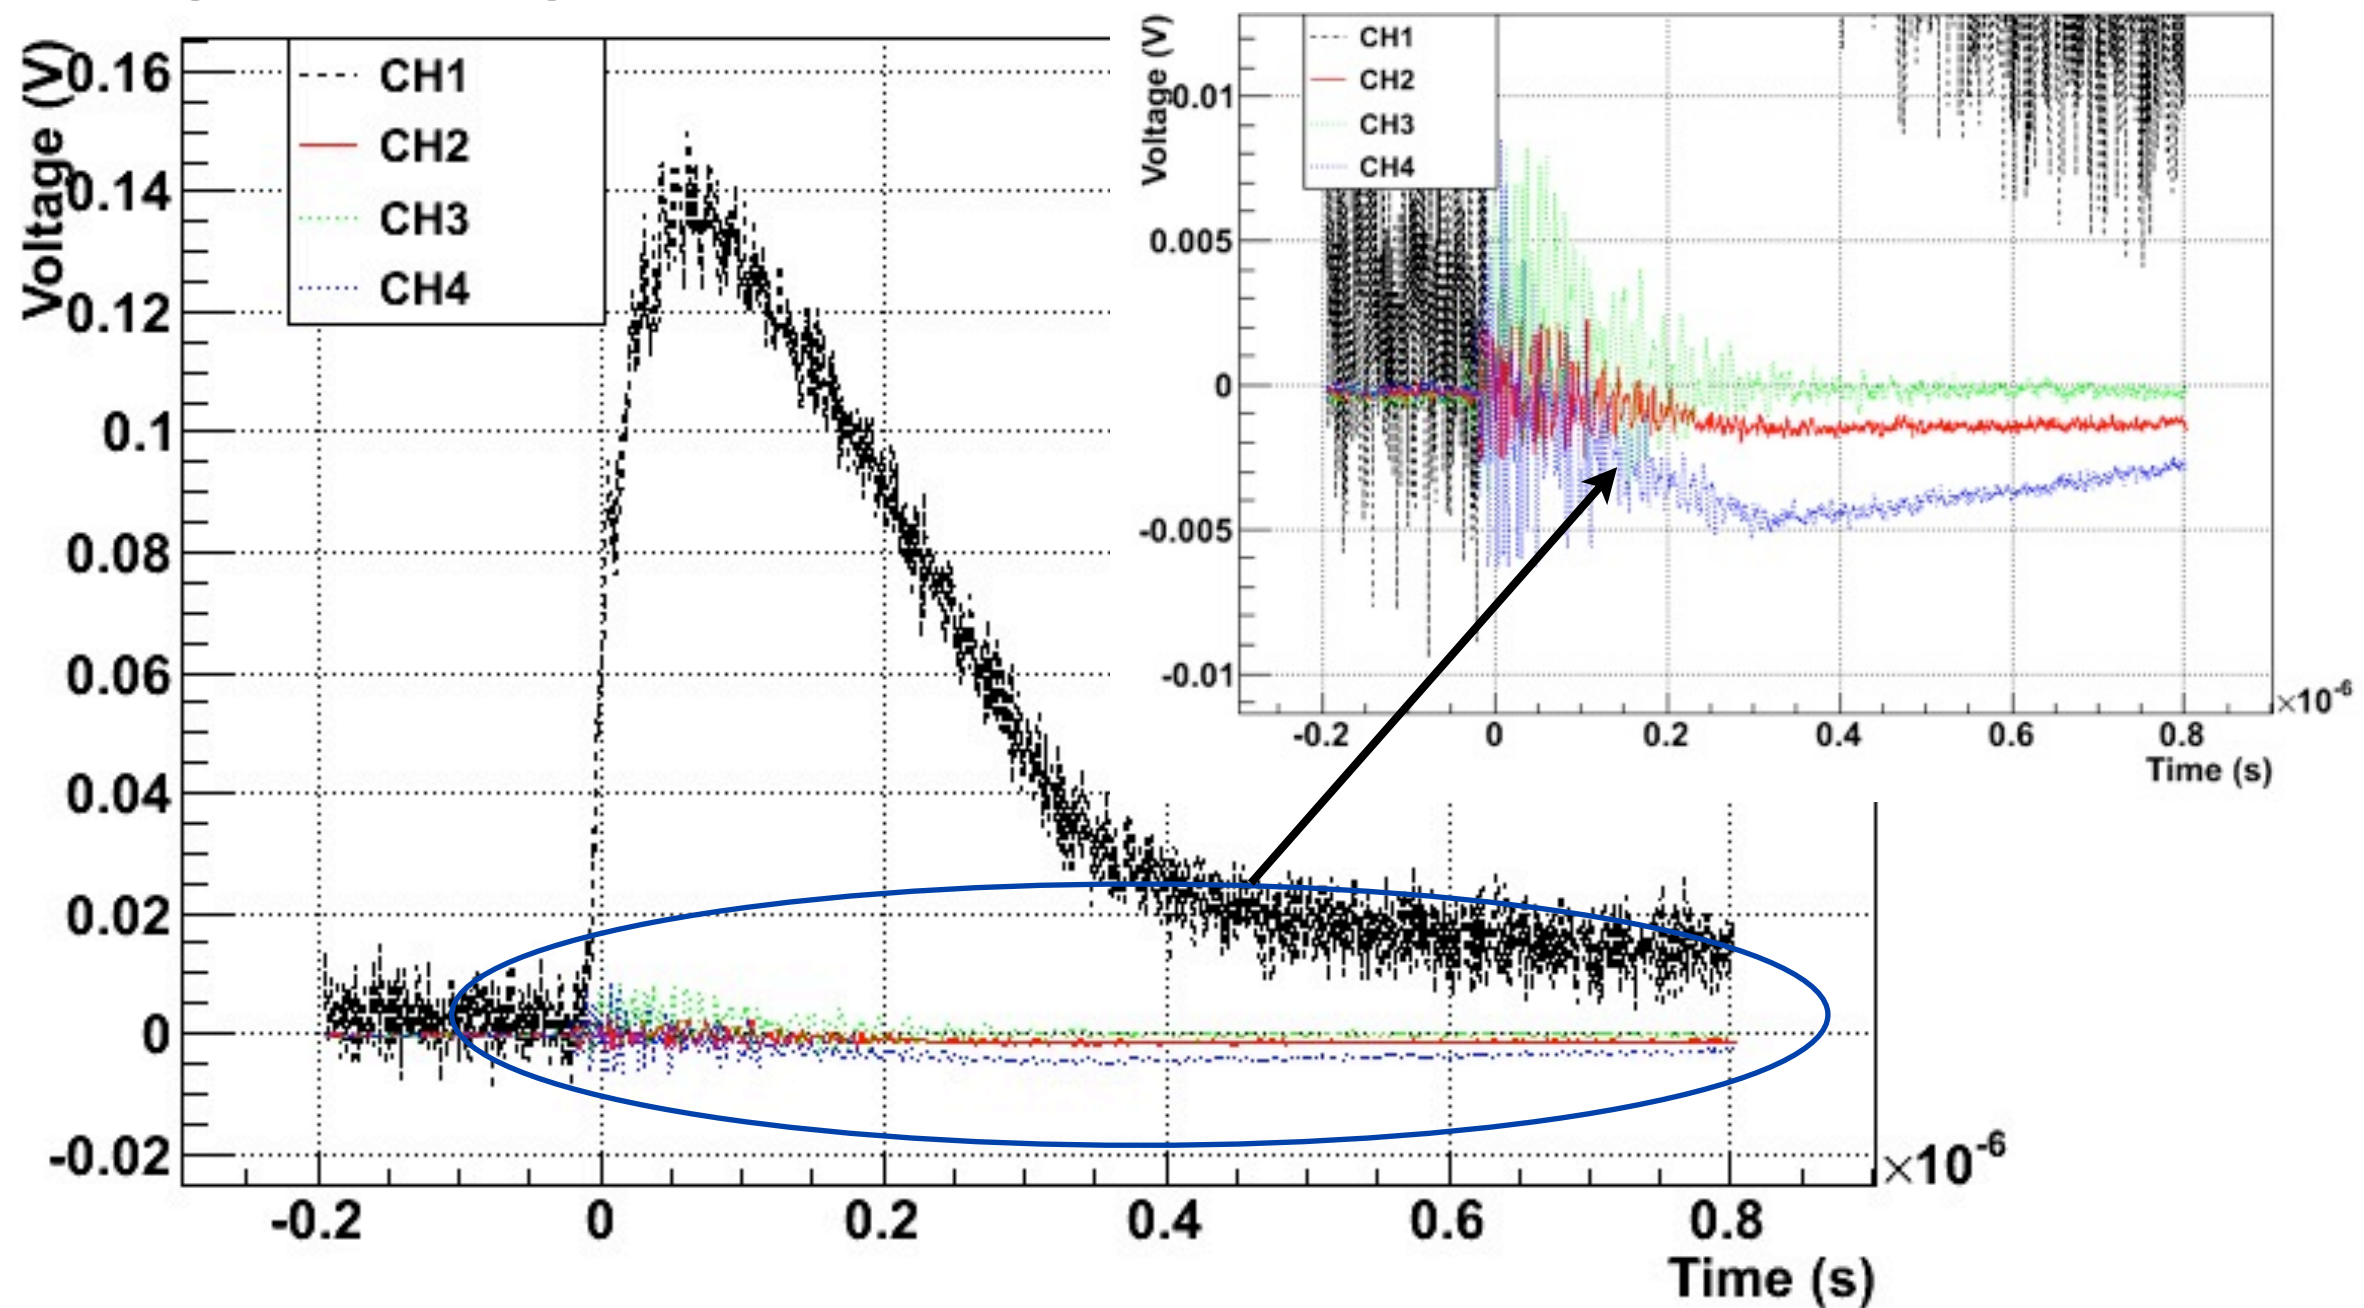
Wave pulses. 1 pilot bunch

Negative signals in FIC and LIC I.I bar

- Chambers were tested in two different conditions:
 - Showed reasonable signals for DC irradiation.
 - Showed inverted signals.
- Problem found to be wrong connection of filter capacitor.
- Test to be performed in the dump line of the PSB (similar experiment conducted last year) to verify the proper functioning of the chambers.
- Possibly, repeat HiradMat experiment for LHC-like irradiation conditions.
