FIC-LIC summary results

E. Nebot, B. Dehning, E. Effinger, V. Grishin.

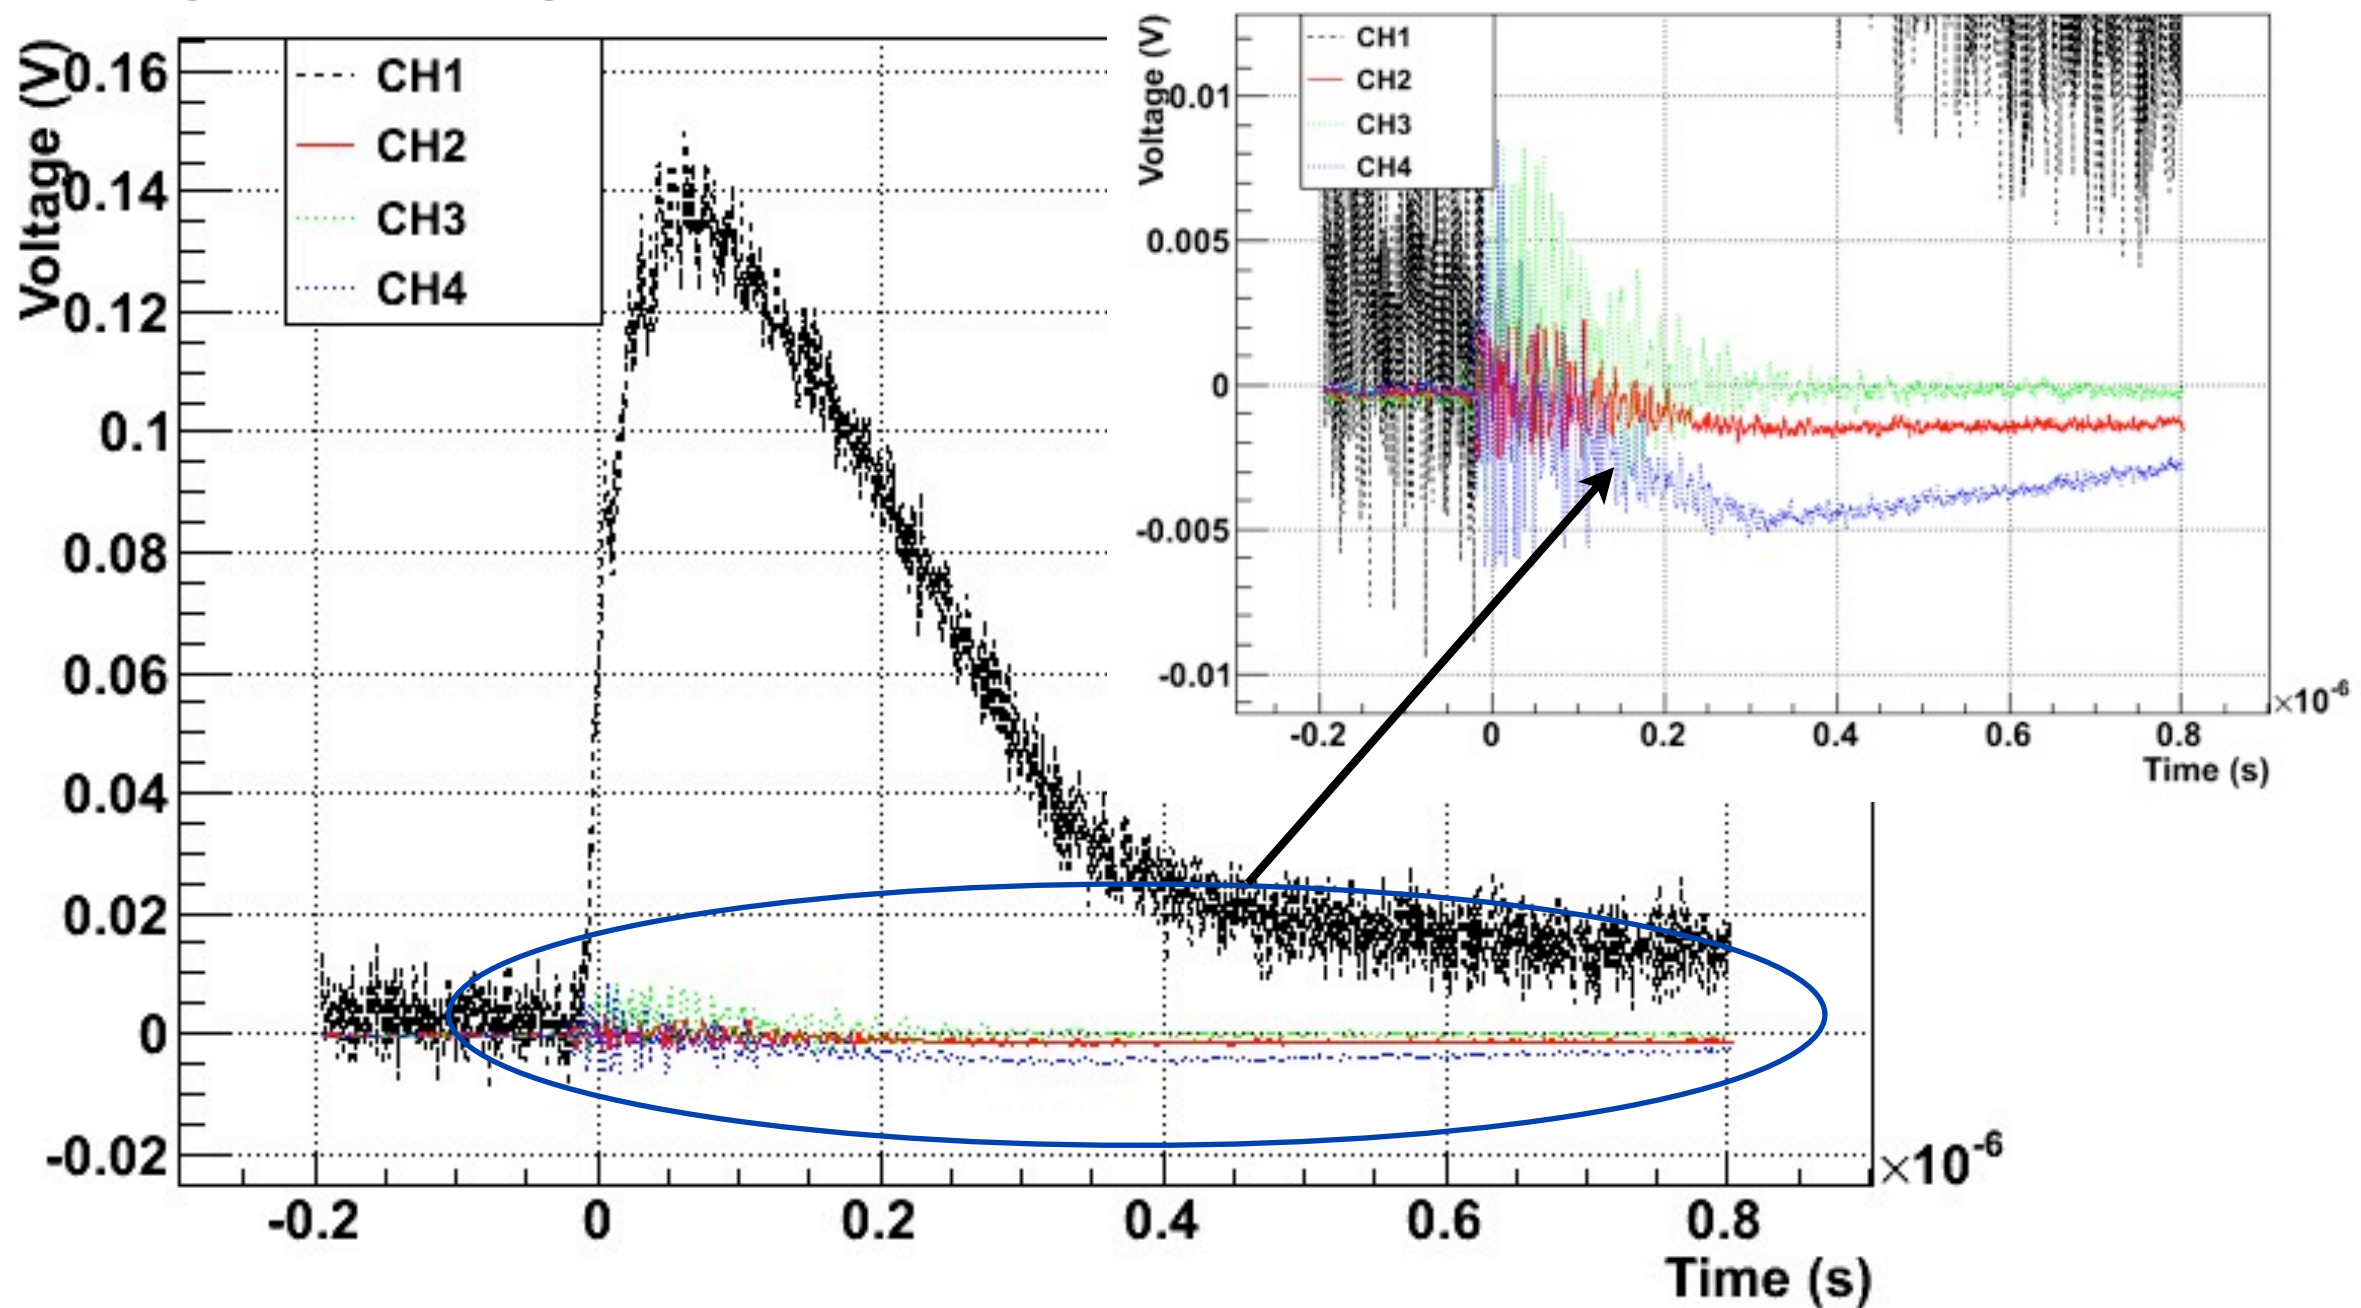
Wave pulses. 1 pilot bunch

Negative signals in FIC and LIC I.I bar

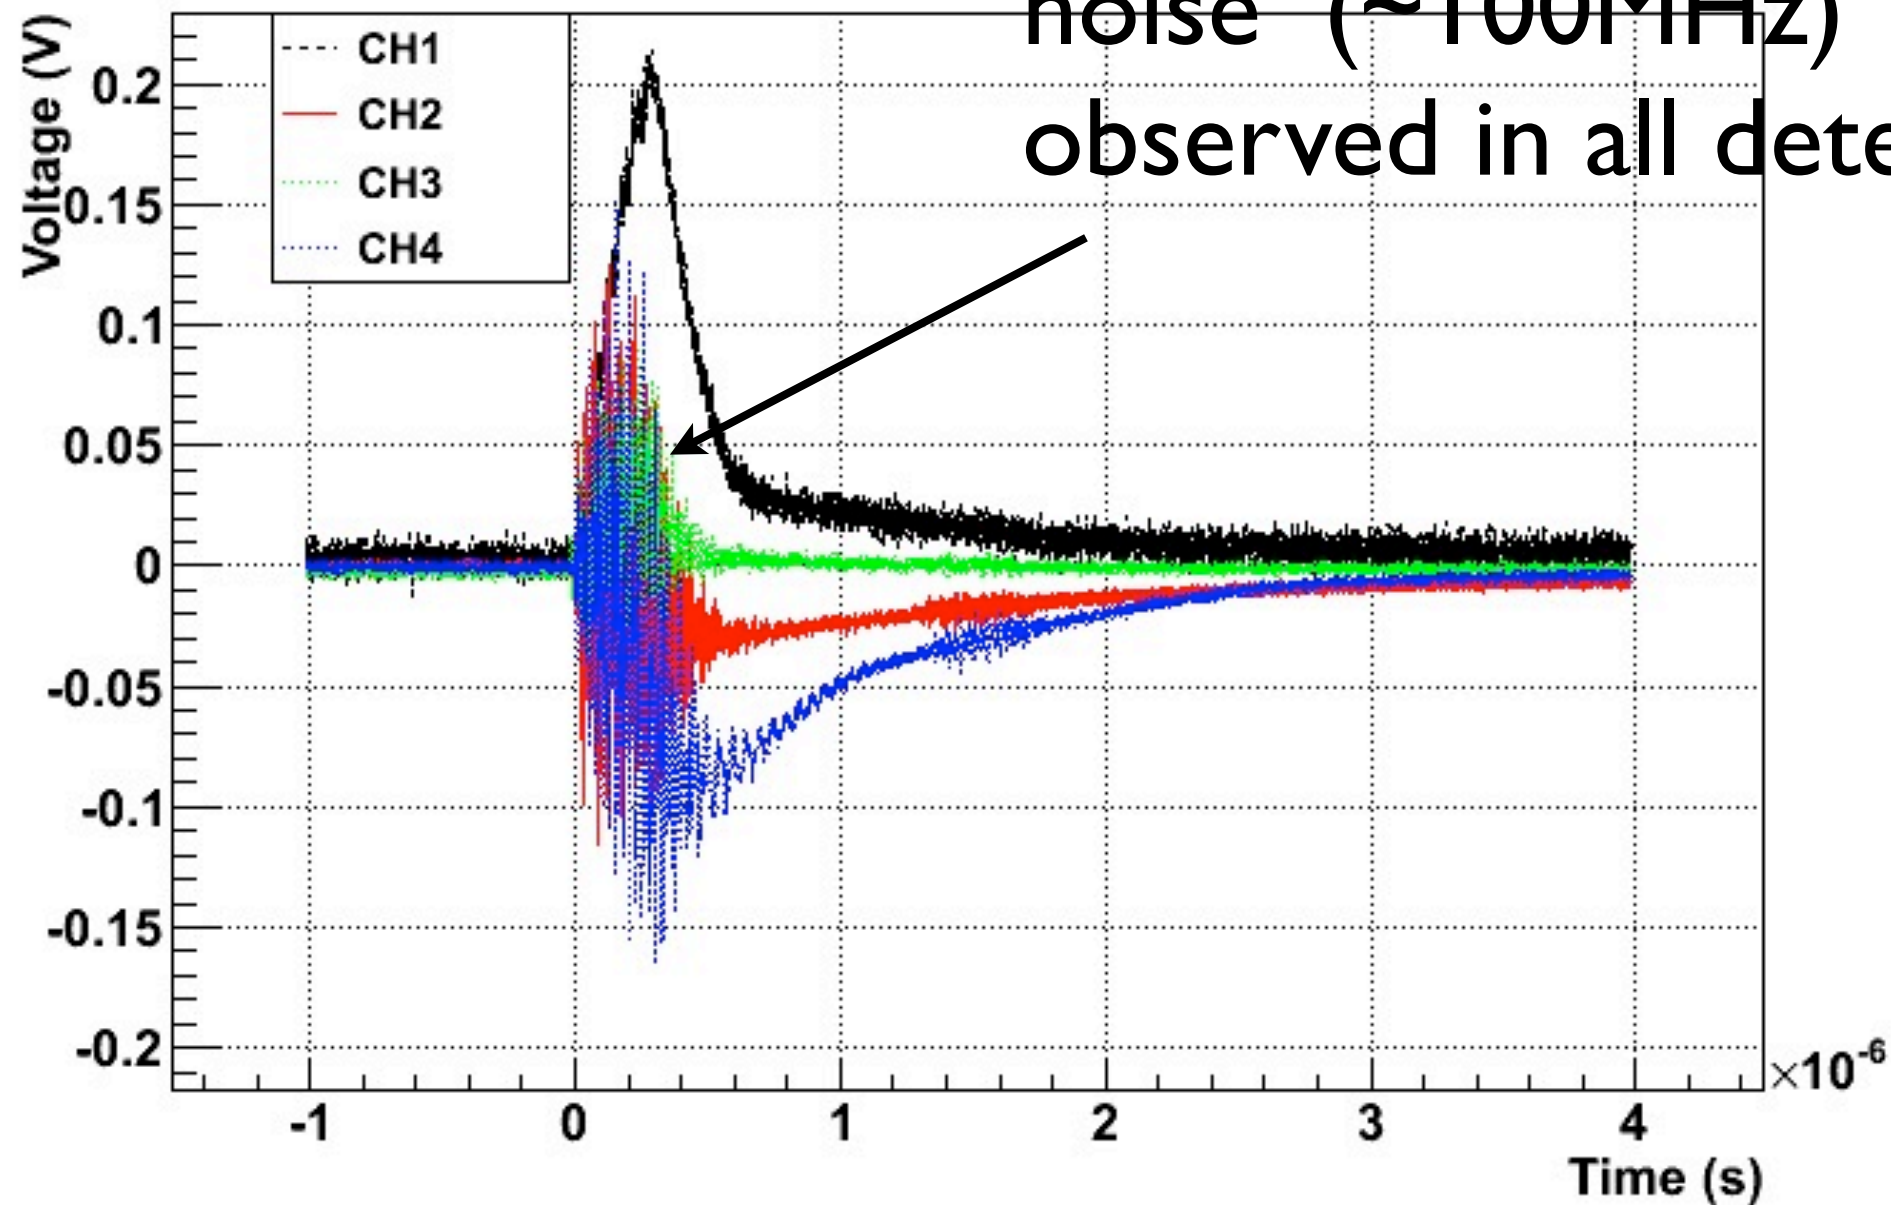
Wave pulses. 6 nominal bunch

20dB attenuation in IC

High frequency
noise ($\sim 100\text{MHz}$)
observed in all detectors

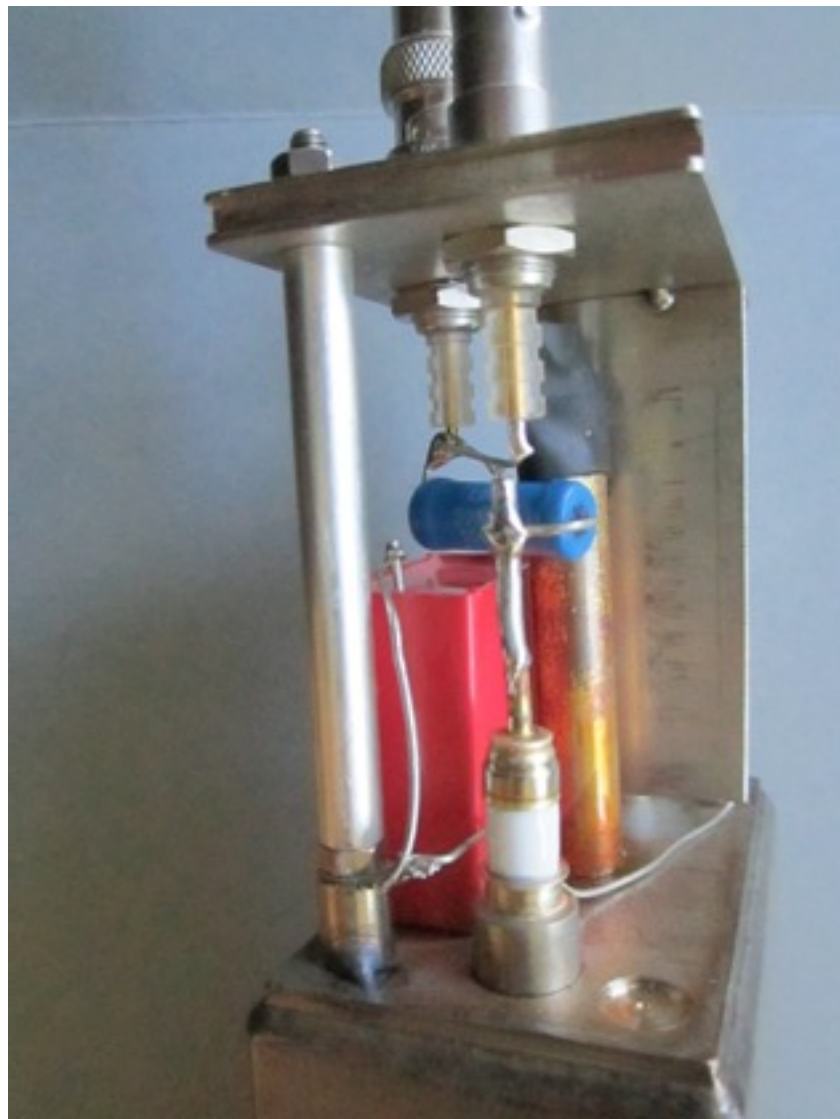
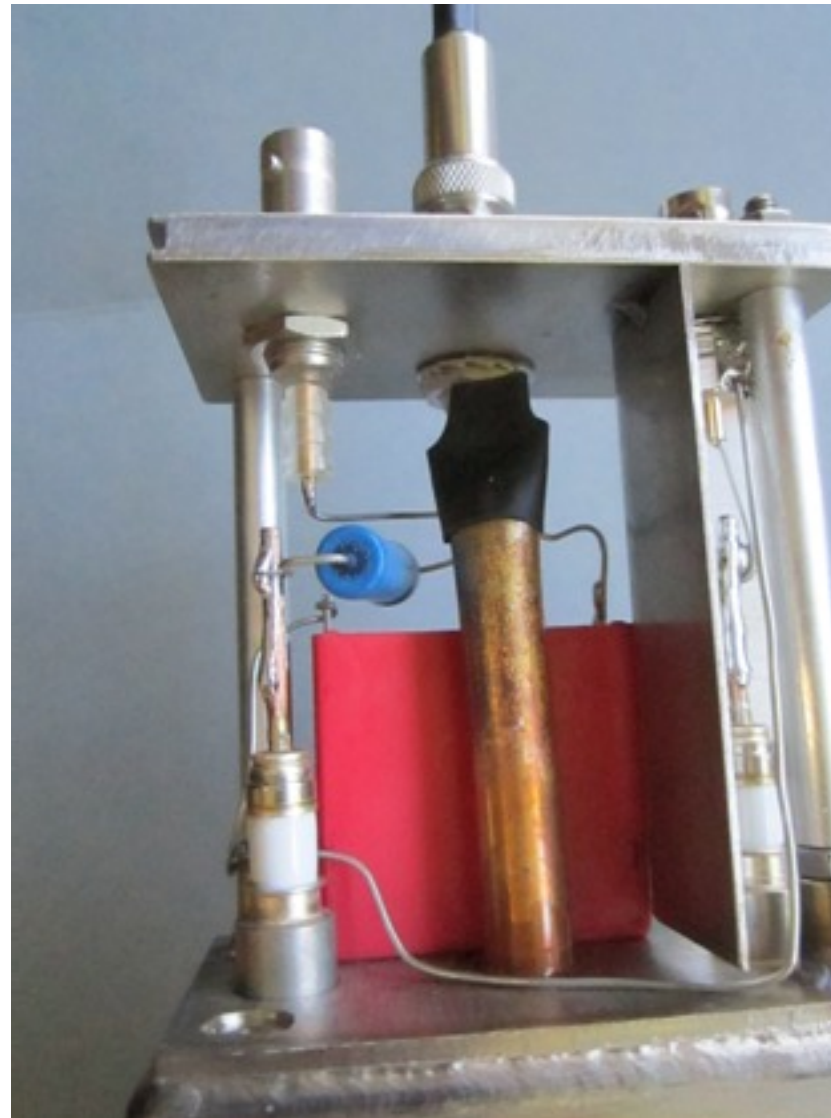
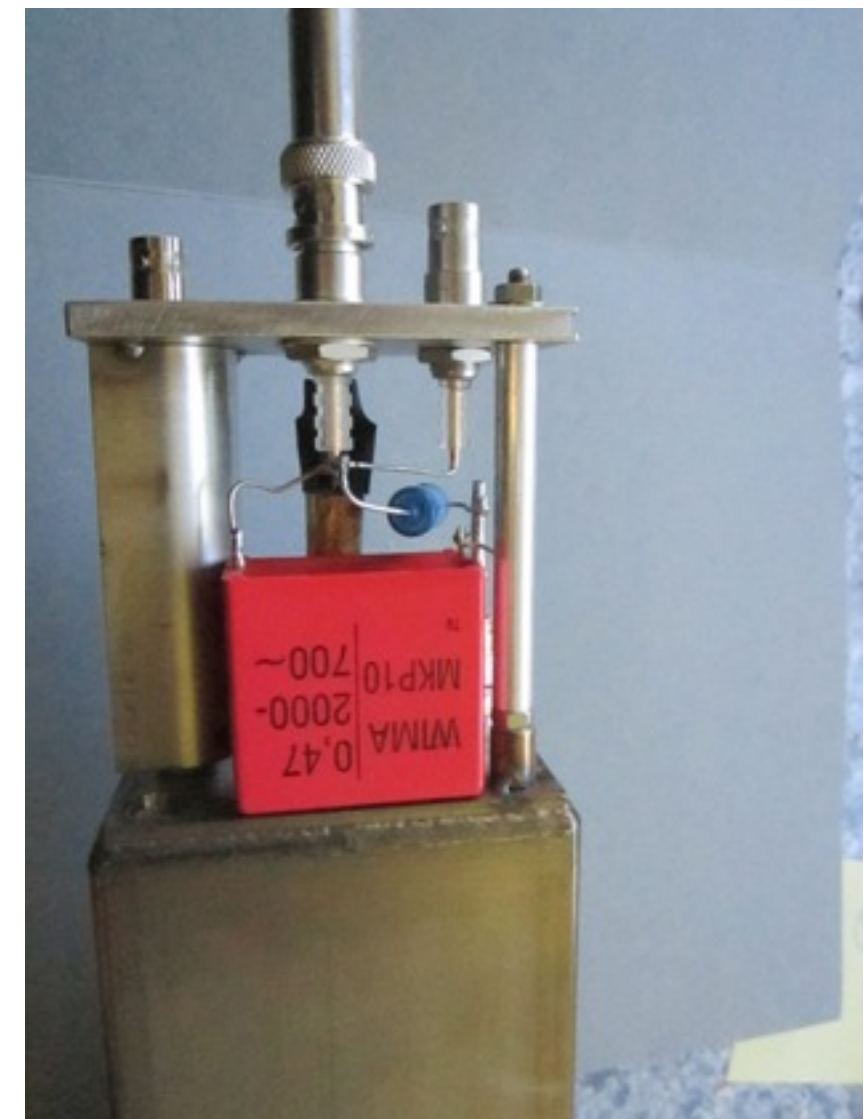
Some photos of the opened FIC

- Under modulation test, SEM and LIC detectors present the same behaviour.
- Modulation test showed that both LIC-FIC behaved as SEM without filter.
- Electrical box was open to find a wrong connection of Capacitor and resistance in both detectors.

- Chambers were tested in two different conditions:
 - Showed reasonable signals for DC irradiation.
 - Showed inverted signals.
- Problem found to be wrong connection of filter capacitor.
- Test to be performed in the dump line of the PSB (similar experiment conducted last year) to verify the proper functioning of the chambers.
- Possibly, repeat HiradMat experiment for LHC-like irradiation conditions.
