COLLIMATOR BA5 Beam Loss installation

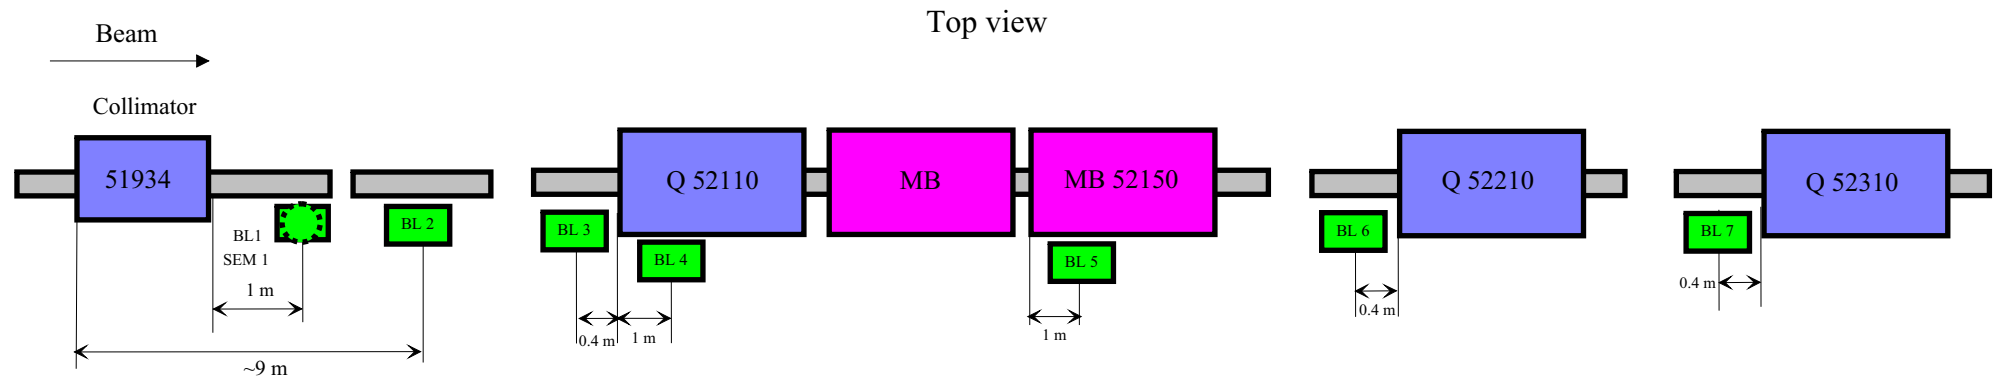
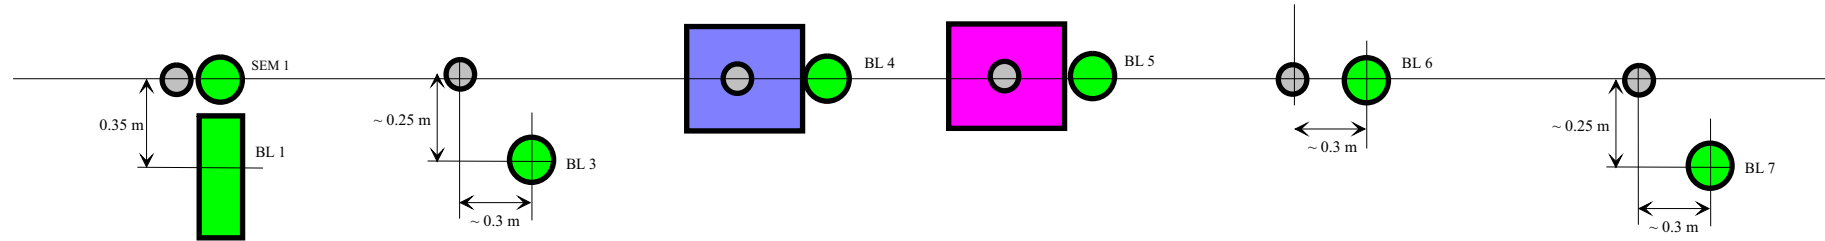
Longitudinal view

- SEM 1 ch 1
- BL 1 ch 2
- BL 2 ch 3
- BL 3 ch 4
- BL 4 ch 5
- BL 5 ch 7
- BL 6 ch 8
